DRAFT RESOURCE MANAGEMENT PLAN
**NATIONAL MONUMENT
TO THE FOREFATHERS**
PLYMOUTH, MASSACHUSETTS

February 2006

Massachusetts Department of Conservation and Recreation
Division of Planning and Engineering
Resource Management Planning Program

WALKER-KLUESING DESIGN GROUP
LANDSCAPE ARCHITECTS
144 LINCOLN STREET, BOSTON, MASSACHUSETTS 02111

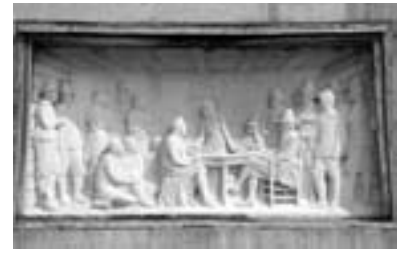
Marble bas-relief

Landing at Plymouth [under Liberty]: This sculpture shows erosion at the most projecting surfaces, particularly the facial features. This type of weathering away of the crystals at the stone surface is referred to as sugaring which results in a roughened surface and loss of detail. The sugaring is most severe where the work is least shielded from wind, rain and salt spray. The edges and recessed areas are in better condition than the central area and projecting features. This tablet shows limited salt accumulation on the surface and has only limited fine cracks in the stone surface and has little surface soiling.

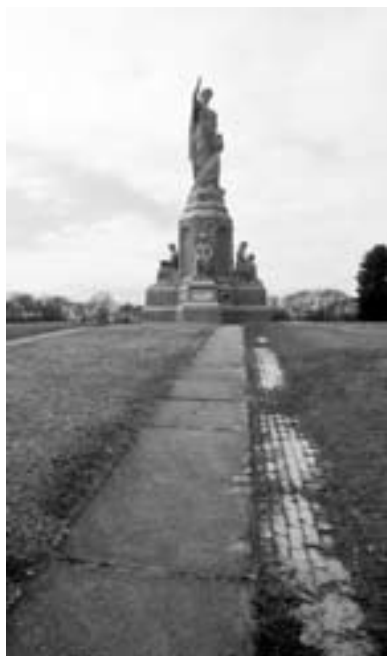
Path to Dedication Panel: Beginning at Allerton Street, this path leads directly to the dedication panel. The existing path has concrete steps flanked by granite fence posts at Allerton Street. The concrete steps are uneven and unsafe. The lowest step has been displaced outward toward the street, creating a significant tripping hazard. An 8' wide concrete walk, in fair condition with several patches, leads to 8 granite steps flanked by granite cheek walls and posts where the path meets the circular drive. The steps have also become displaced, creating a tripping hazard, and the uppermost tread is broken. An approximately 12' wide by 110' long path continues between the circular drive and the base of the monument, where it is finished with a field of hexagonal asphalt pavers [approximately 8" across] and edged with four courses of 4" x 12" rectangular asphalt pavers. Research indicates that these exposed aggregate finish pavers were installed around 1897. The path was restored in the fall of 2003, when the pavers were removed, the path regraded and all salvageable historic pavers, along with some replacement pavers, were installed on a new subbase. Through this project, about 10-15% of the historic hexagonal pavers were replaced in kind. The path is currently in excellent condition. A granite threshold placed where path intersects the circular drive had been carefully profiled to match the profile of the path. When the edge pavers were reset along the edges of the path, they were not set in the proper profile to create a gutter at the edge of the path as suggested by the granite threshold.

Repair/Reset the Steps at the Path to the Dedication Panel: Reset the lower concrete step where the path meets Allerton Street. Remove and rebuild the granite steps and cheek walls above. Repair the broken step. Replace the foundation as required. Provide appropriate handrails.

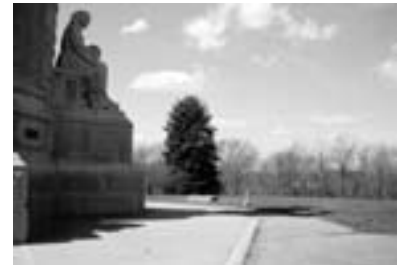
Path at base of monument

Path at Base of Monument: Both of the existing pedestrian paths terminate near the base of the monument. Immediately around the base, an octagonal area, approximately 63' across, is finished in concrete paving within granite curbing. Research indicates that this area was historically finished with a variety of materials, including grass and tiles in the 1890s and a granolithic material beginning in 1900. The granite curb is likely original. The existing concrete was installed in 1987 and exhibits minor cracking and a few spalls where the concrete meets the curb. Most of the sealant joints have become unbonded. No expansion joint was provided at the base of the monument.

Path at Base of Monument: The concrete area above the raised granite curb should be restored to lawn as it was historically. The asphalt area should be made a chip seal surface to restore the appearance of the historic gravel surface. Some indication of the original diameter of the paved pedestrian area around the base of the monument should be provided and the awkward transition of materials at the pedestrian paths should be eliminated. This can be accomplished by providing a stone circular marker at the outer diameter of the original paved circle and extending the chip seal surface to that point. The alternative of extending the paved area to the original diameter is not recommended at this time because current use does not appear to warrant the expansion. If it is observed that use requires additional paved surface in this location, the diameter of the paved circle should be expanded to its original dimension.

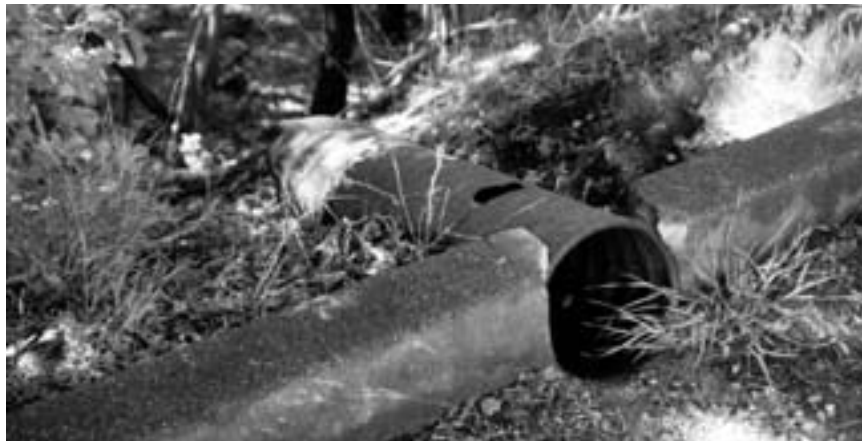
*Corrugated metal pipe
at the concrete curb
on the circular drive*

Replace Curbing with Barrier Rails: Remove the concrete curb and drainage structures on the outer edge of the circular drive and replace with an appropriate barrier rail that will provide a higher degree of public safety. This action will also significantly reduce down slope erosion conditions created by the curbing and drainage structures.

Erosion Repairs: Repair the erosion created by the point source discharges once the concrete curbing is removed.
